Jackson Hole, Wyoming Environmental Restoration Draft Feasibility Study

Draft Feasibility Study
and
Appendixes A - B

April 2000

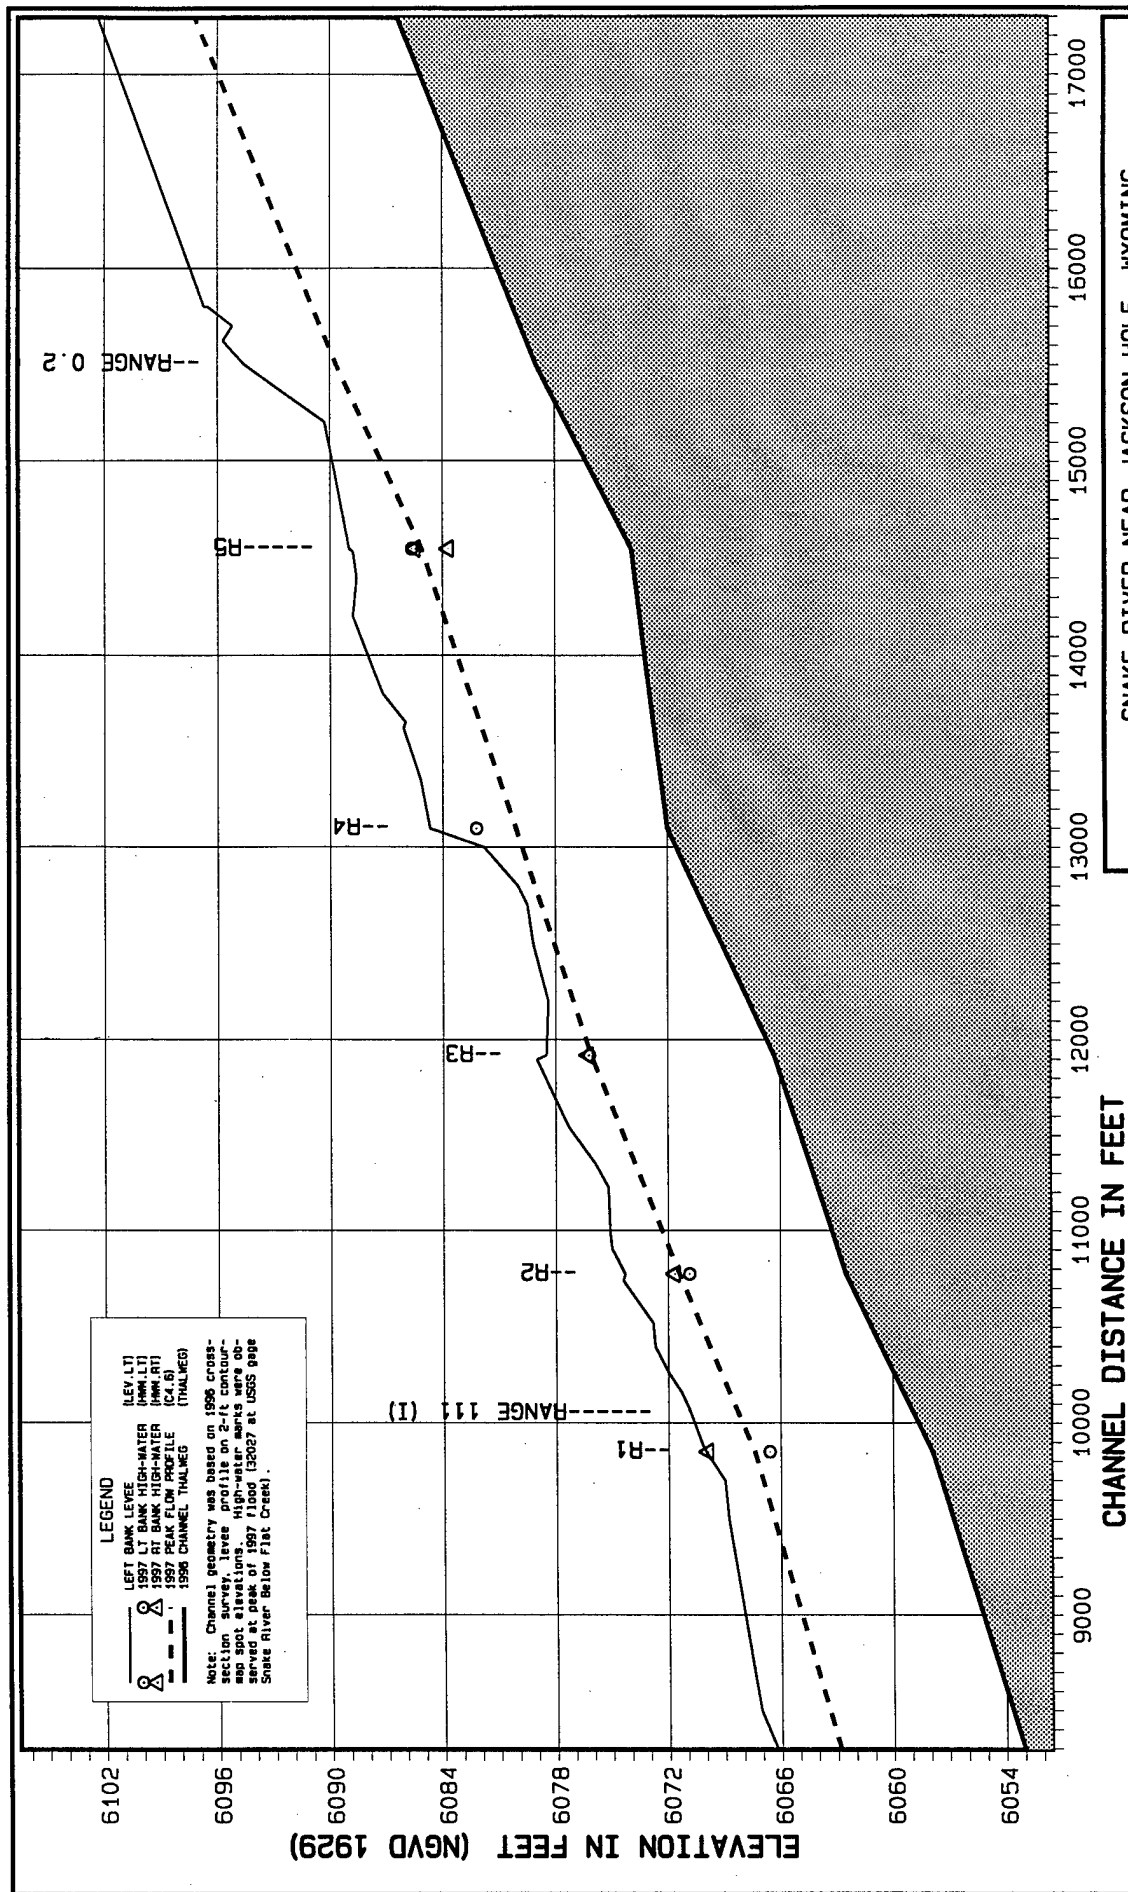
OBSERVED VS CALCULATED WATER-SURFACE PROFILES
